QRC EVALUATION OF MATERIALS AND PROCESSES

University of Dayton Research Institute
University of Dayton
Dayton, Ohio 45469

OCTOBER 1982

Final Report for Period 1 April 1980 - 14 June 1982

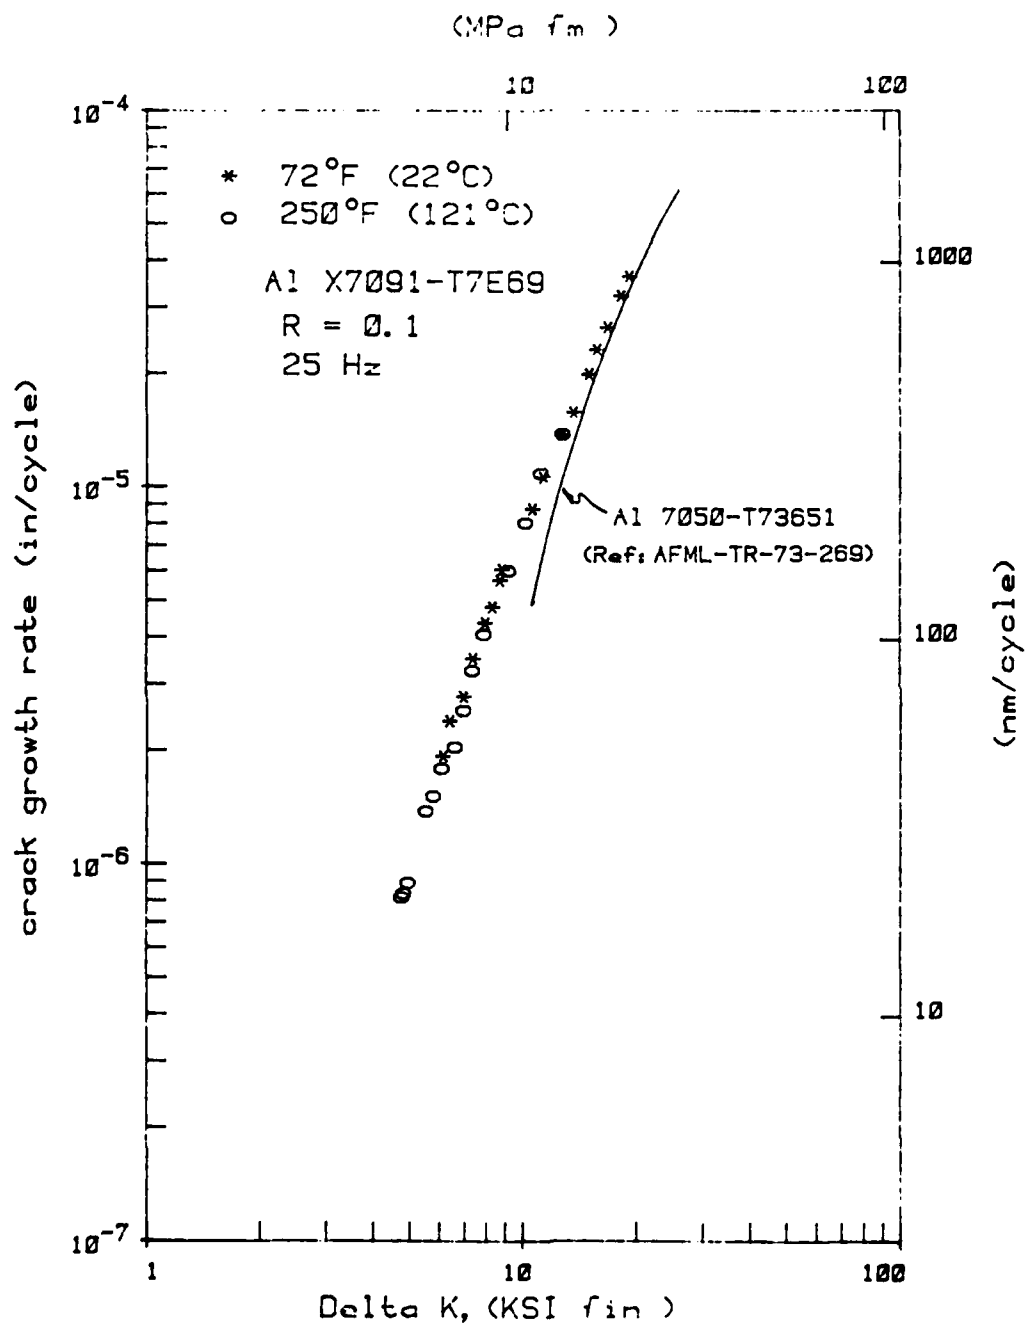
Figure 33. Constant Amplitude Fatigue Crack Growth Data for X7091-T7E69 for Room Temperature and 250°F (121°C) Test Environments.

Constant amplitude fatigue crack growth rate data for X7091-T7E69 are presented in Figure 33 for both room temperature and 250°F (121°C) test environments. Differences between the two data sets are indistinguishable over the range of stress intensities examined, indicating no effect of this temperature on fatigue crack growth properties. Also presented is a data trend line for 7050-T7E69^[11] at room temperature and $R=0.1$. Results show a poorer performance in fatigue crack growth for X7091-T7E69 as compared to the conventional aluminum material, with differences diminishing only at stress intensities approaching the material's fracture toughness limit.

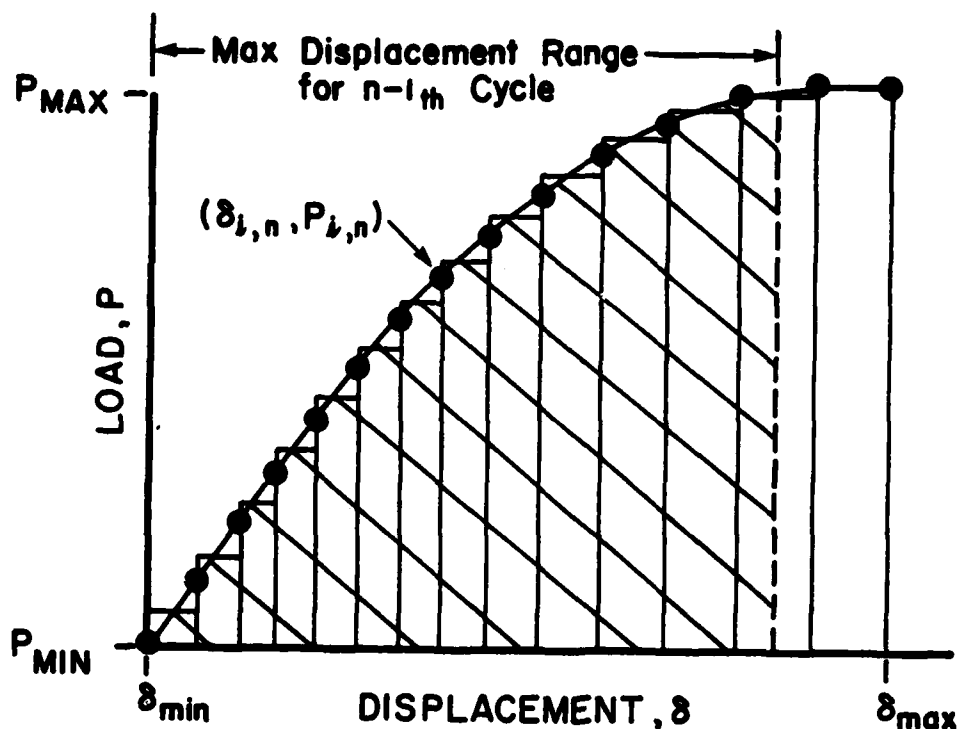
Figure 37. Graphical Method for Determining Area Under Load-Displacement Record for nth Cycle.

(2) J-Analysis Routine. If the nonlinear analysis approach was specified, control is transferred from the reading routine to the J-analysis routine. In this routine, the displacement array is similarly scanned for the minimum value. Upon determining this minimum point the successive load-displacement points are used to determine the area under the curve. The manner for accomplishing the integration is illustrated in Figure 37.

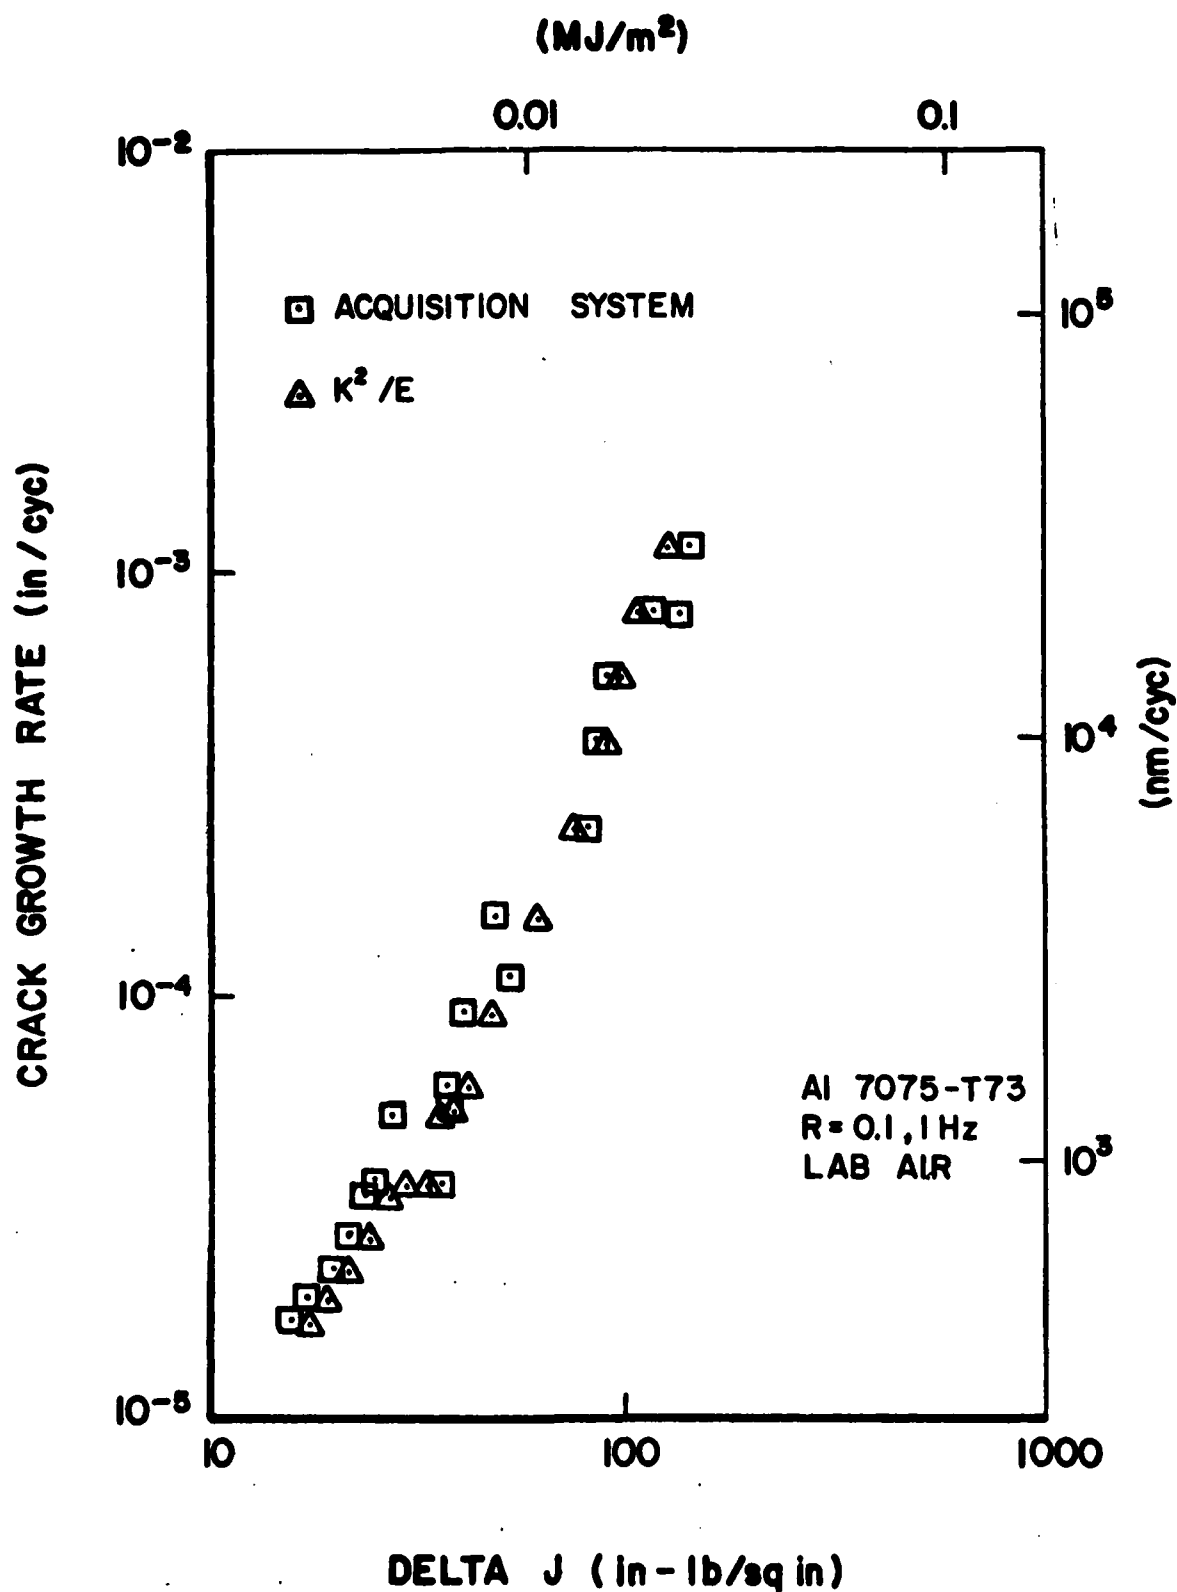
Figure 39. NLFM Crack Growth Data Obtained via Acquisition System and Analytical Methods.

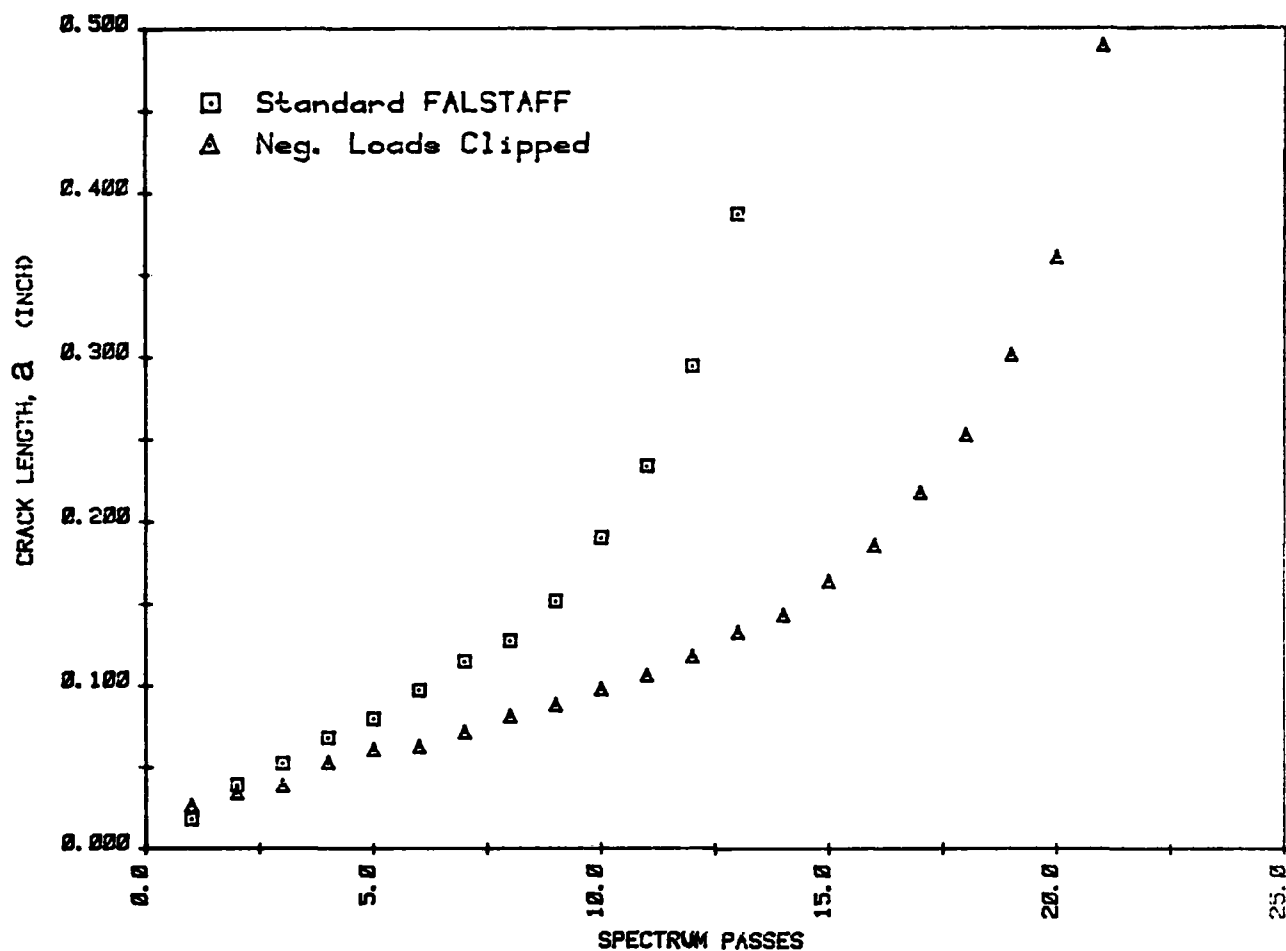
Negative Loads Clipped (SPEC. #2), 10X

Figure 42. Fatigue Crack Growth Data for FALSTAFF with Negative Loads Clipped.

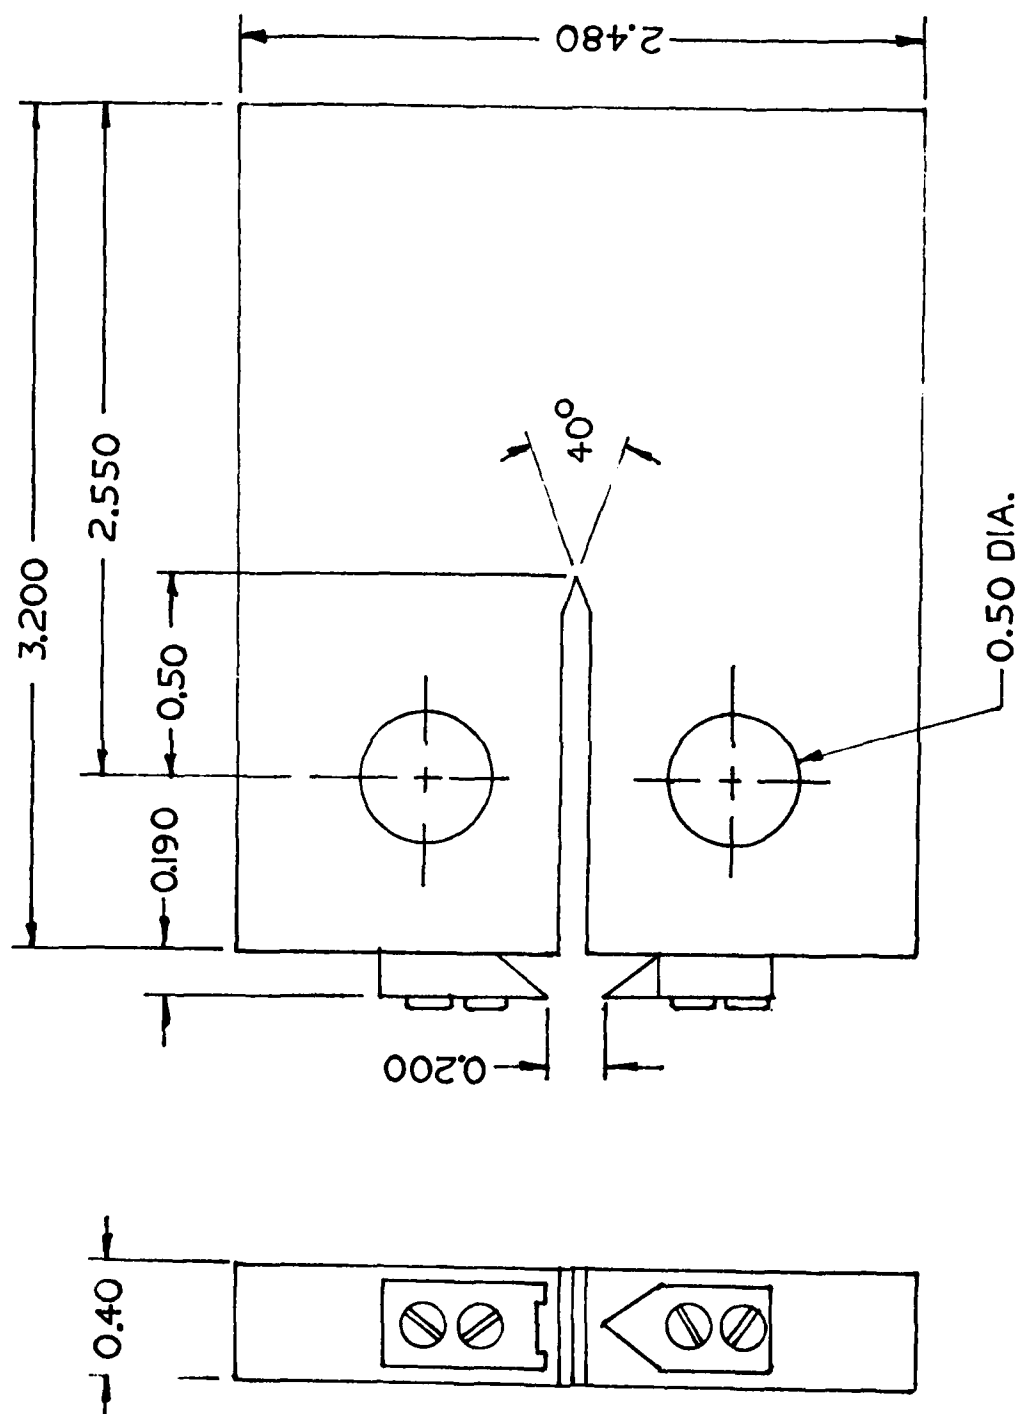
Figure 45. WOL Specimen Geometry.

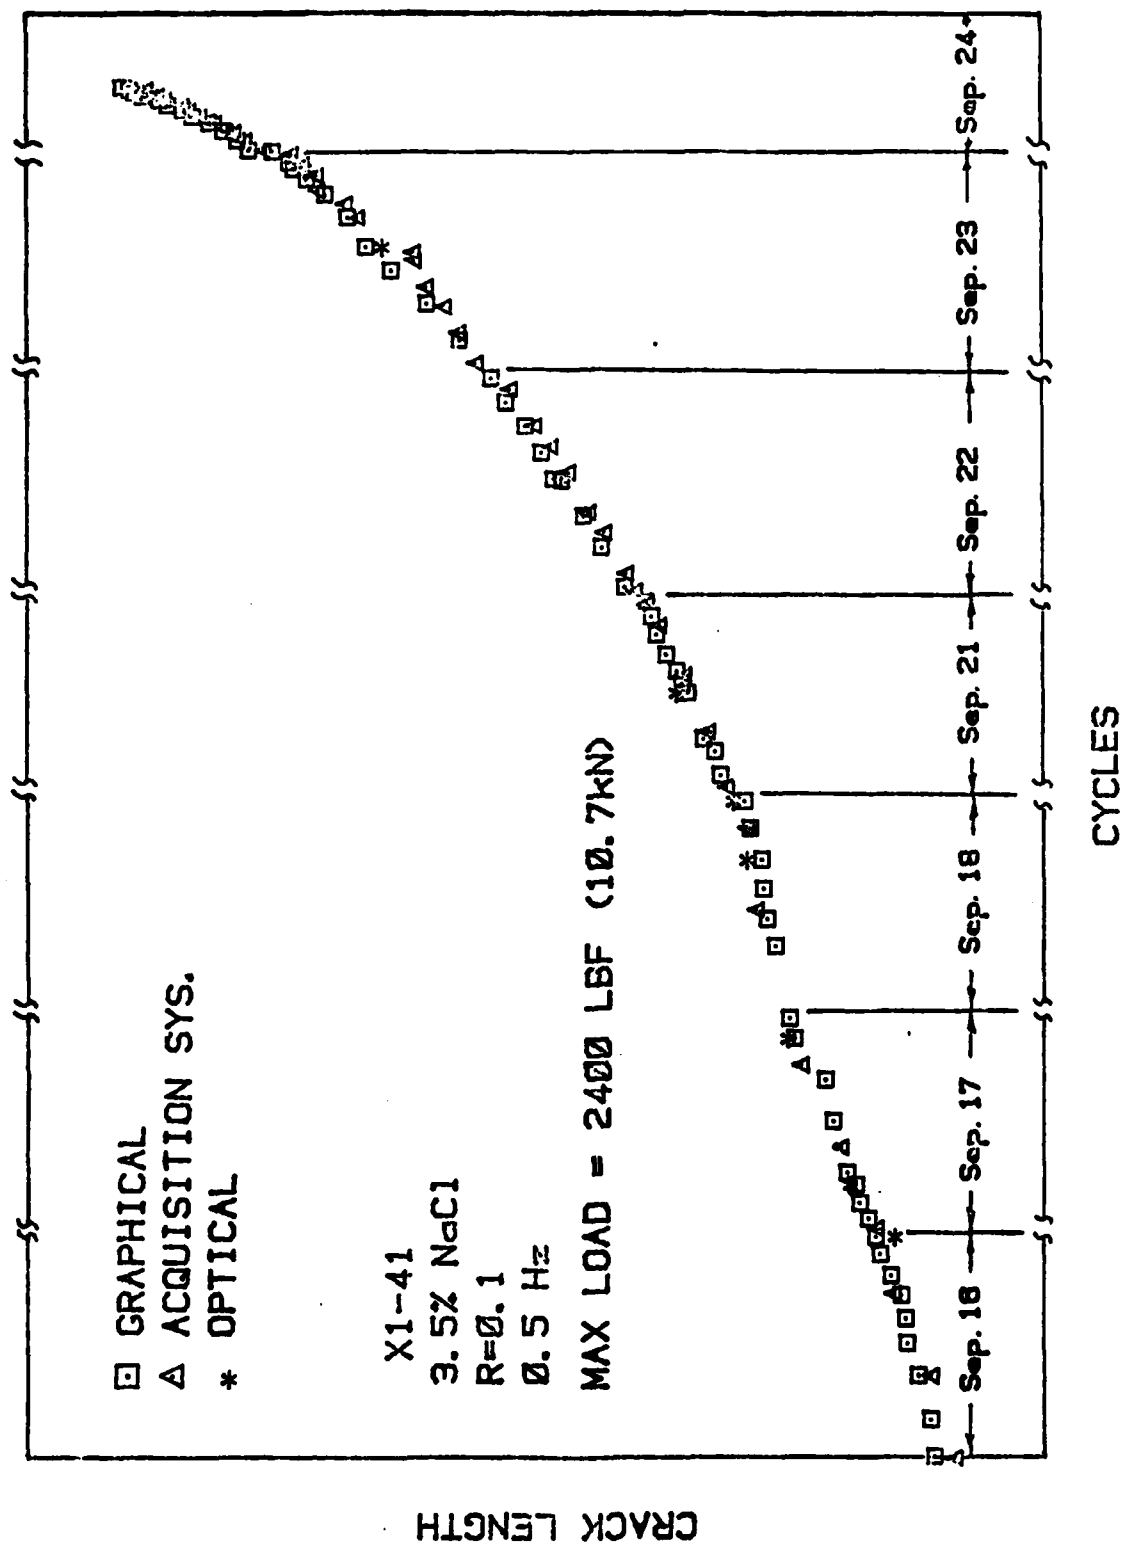
Figure 47. Crack Length vs. Cycles Record for Specimen X1-41.

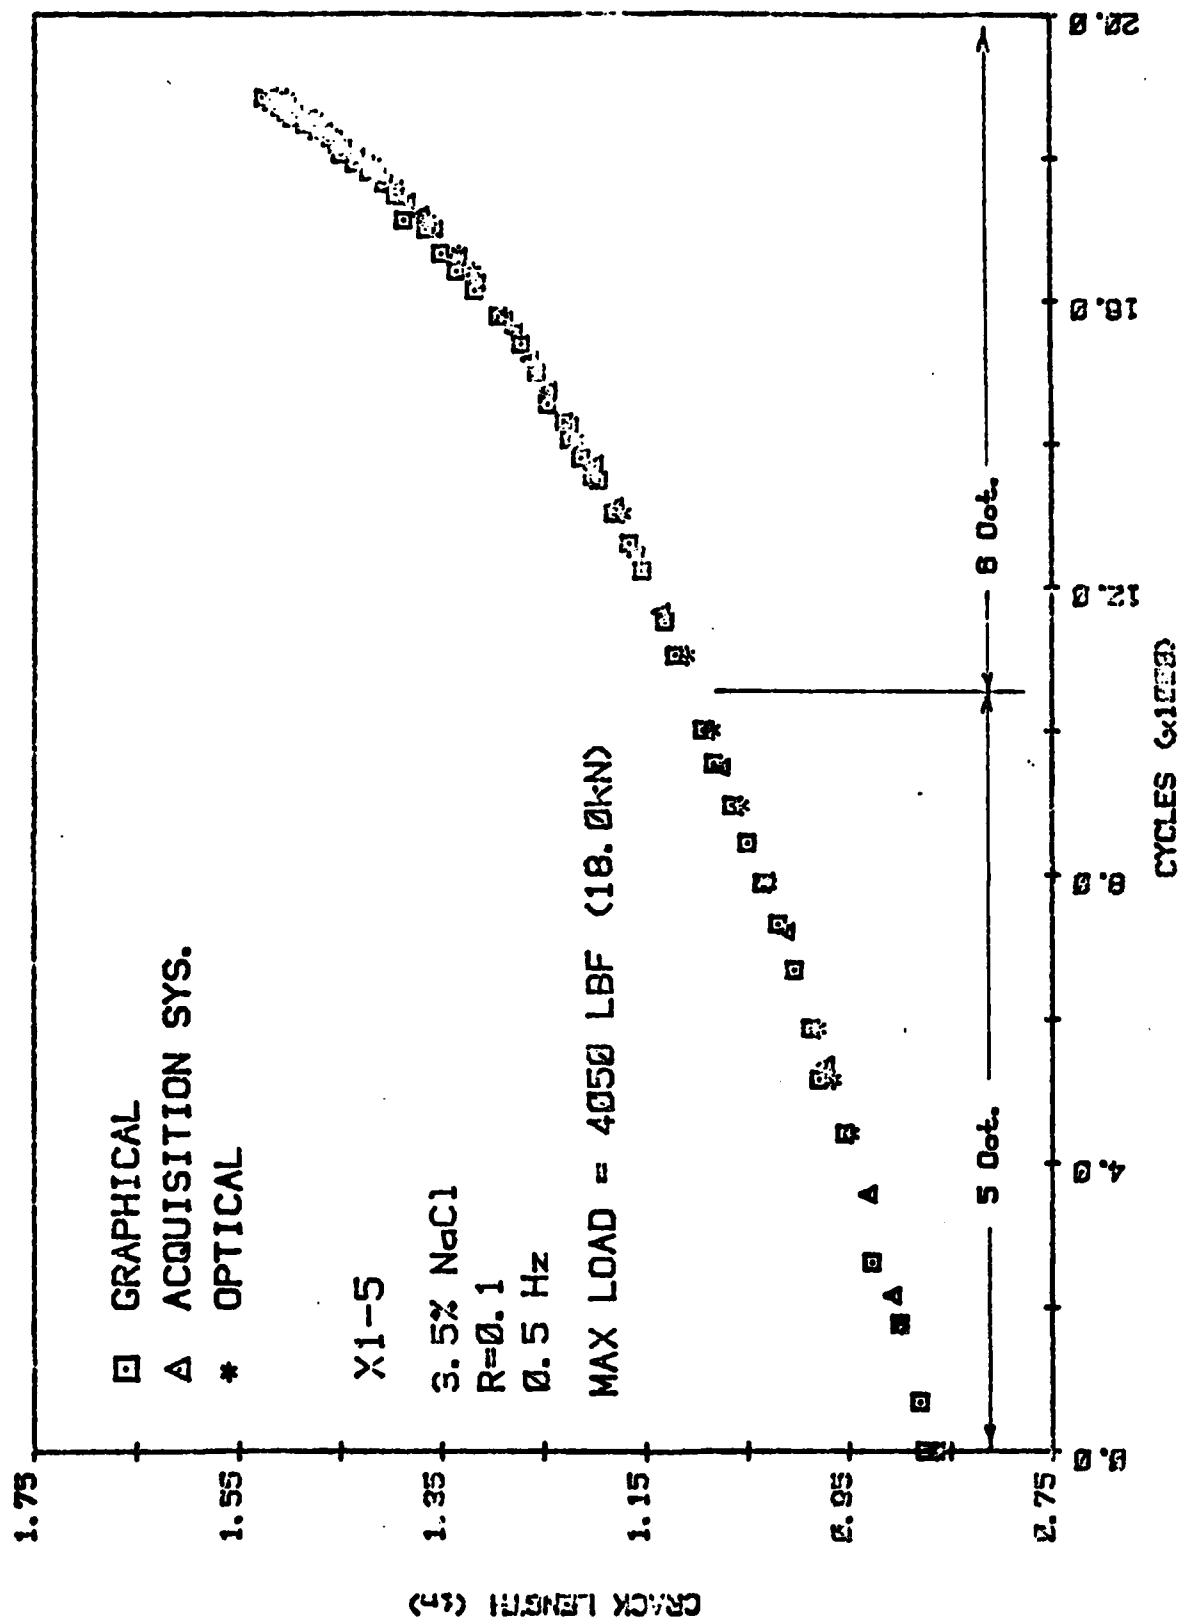
Figure 48. Crack Length vs. Cycles Record for Specimen X1-5.

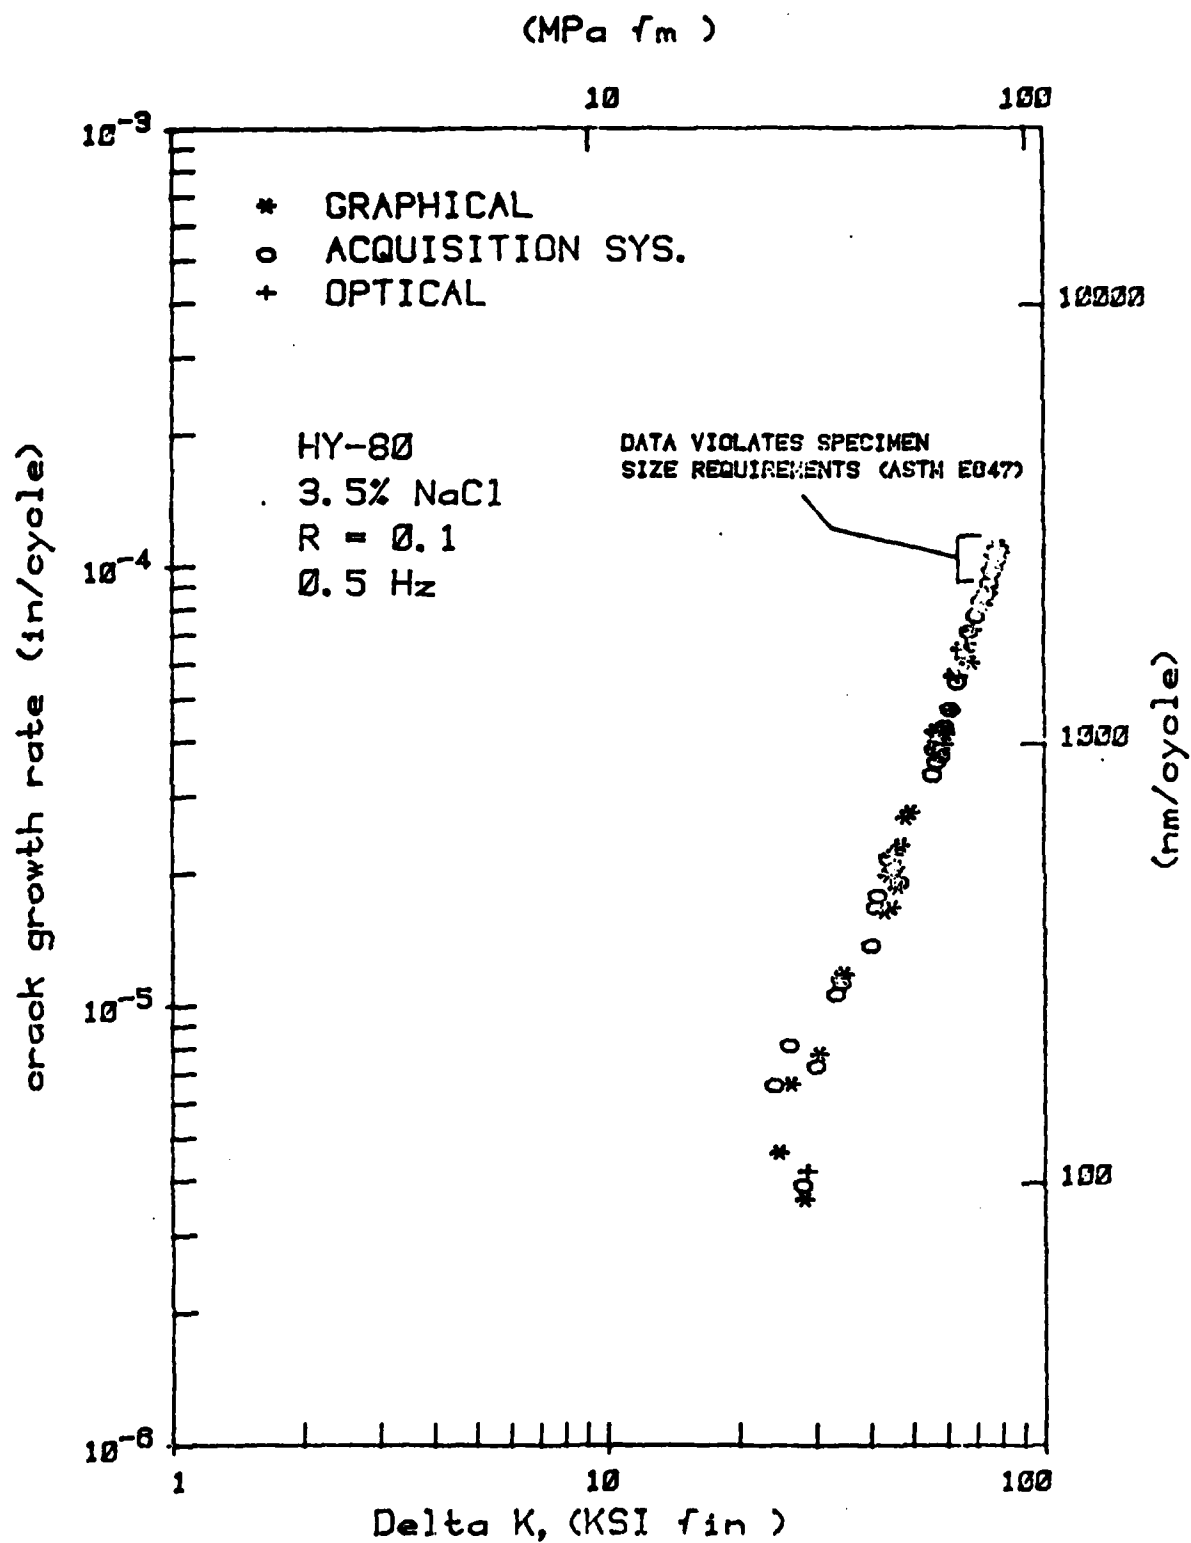
Figure 50. Fatigue Crack Growth Rate Results Based on Graphical, Acquisition System, and Optical Methods.

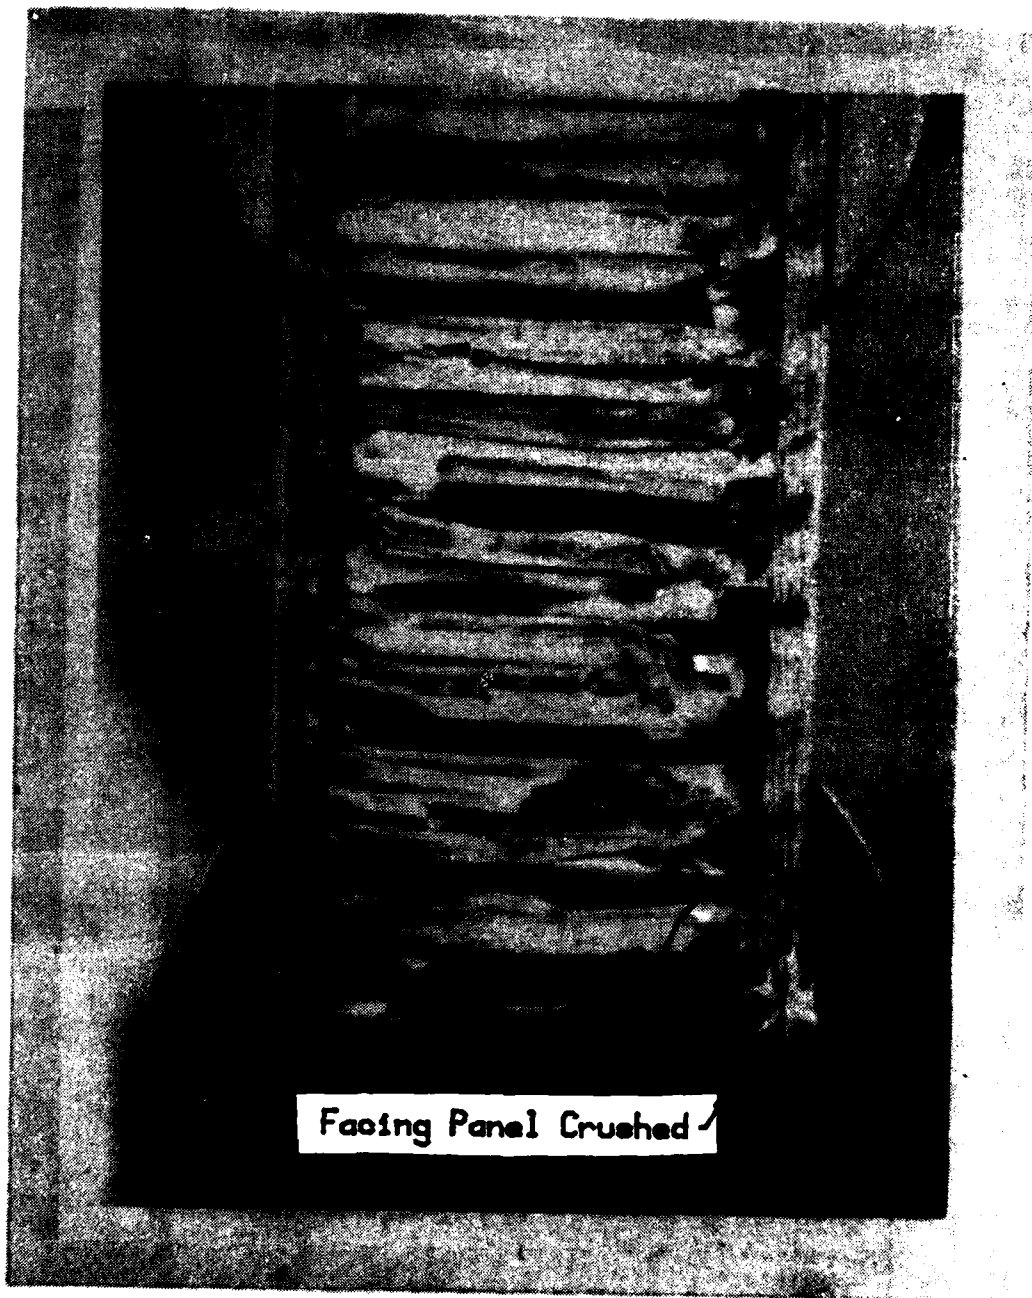
Figure 52. Typical Failure Mode for Edgewise Compression Testing.

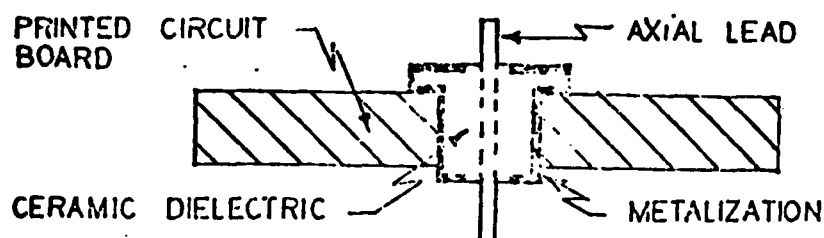
CROSS SECTION OF FEEDTHROUGH CAPACITOR

The "feedthrough" type of capacitor was listed as shorted in Failure Report 1. Testing revealed this "shorted" condition

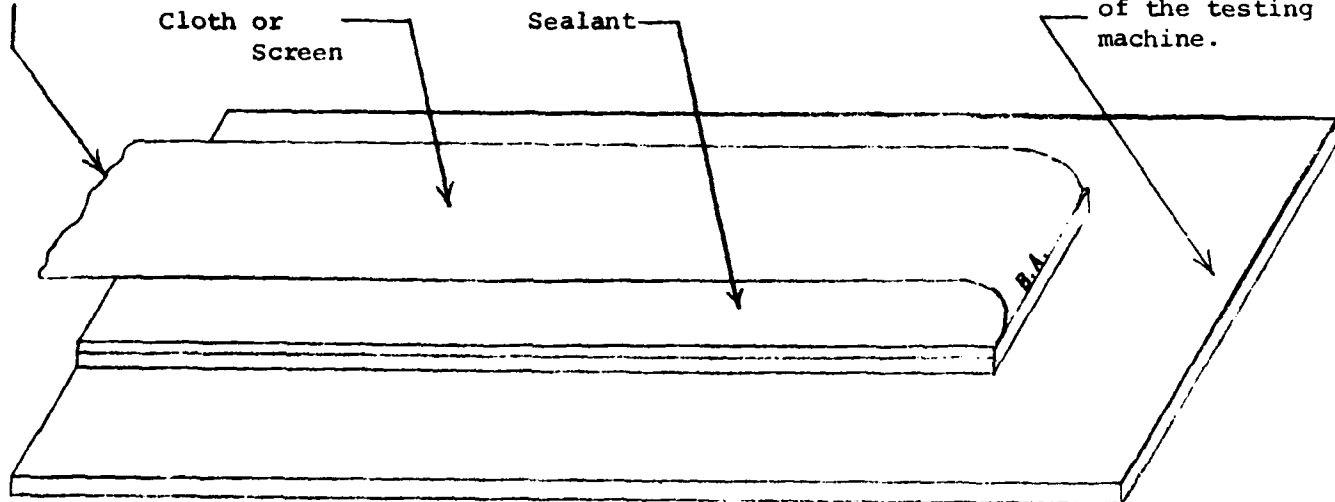
Figure 58. Standard Peel Test Panel.

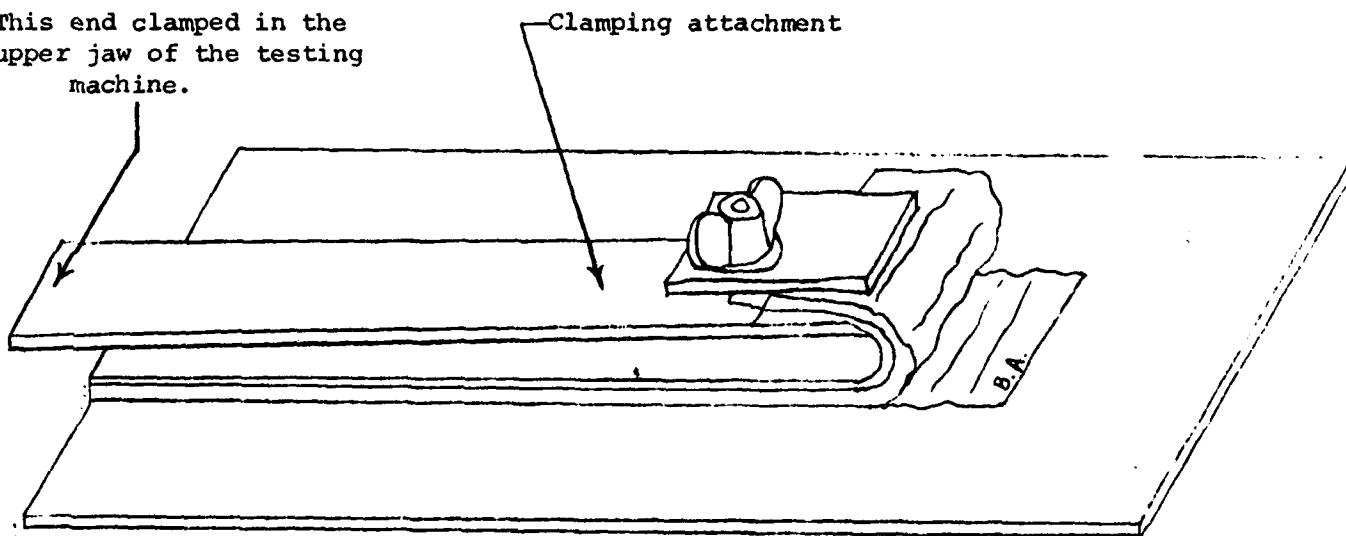
Figure 59. Peel Test Panel and Adapter.

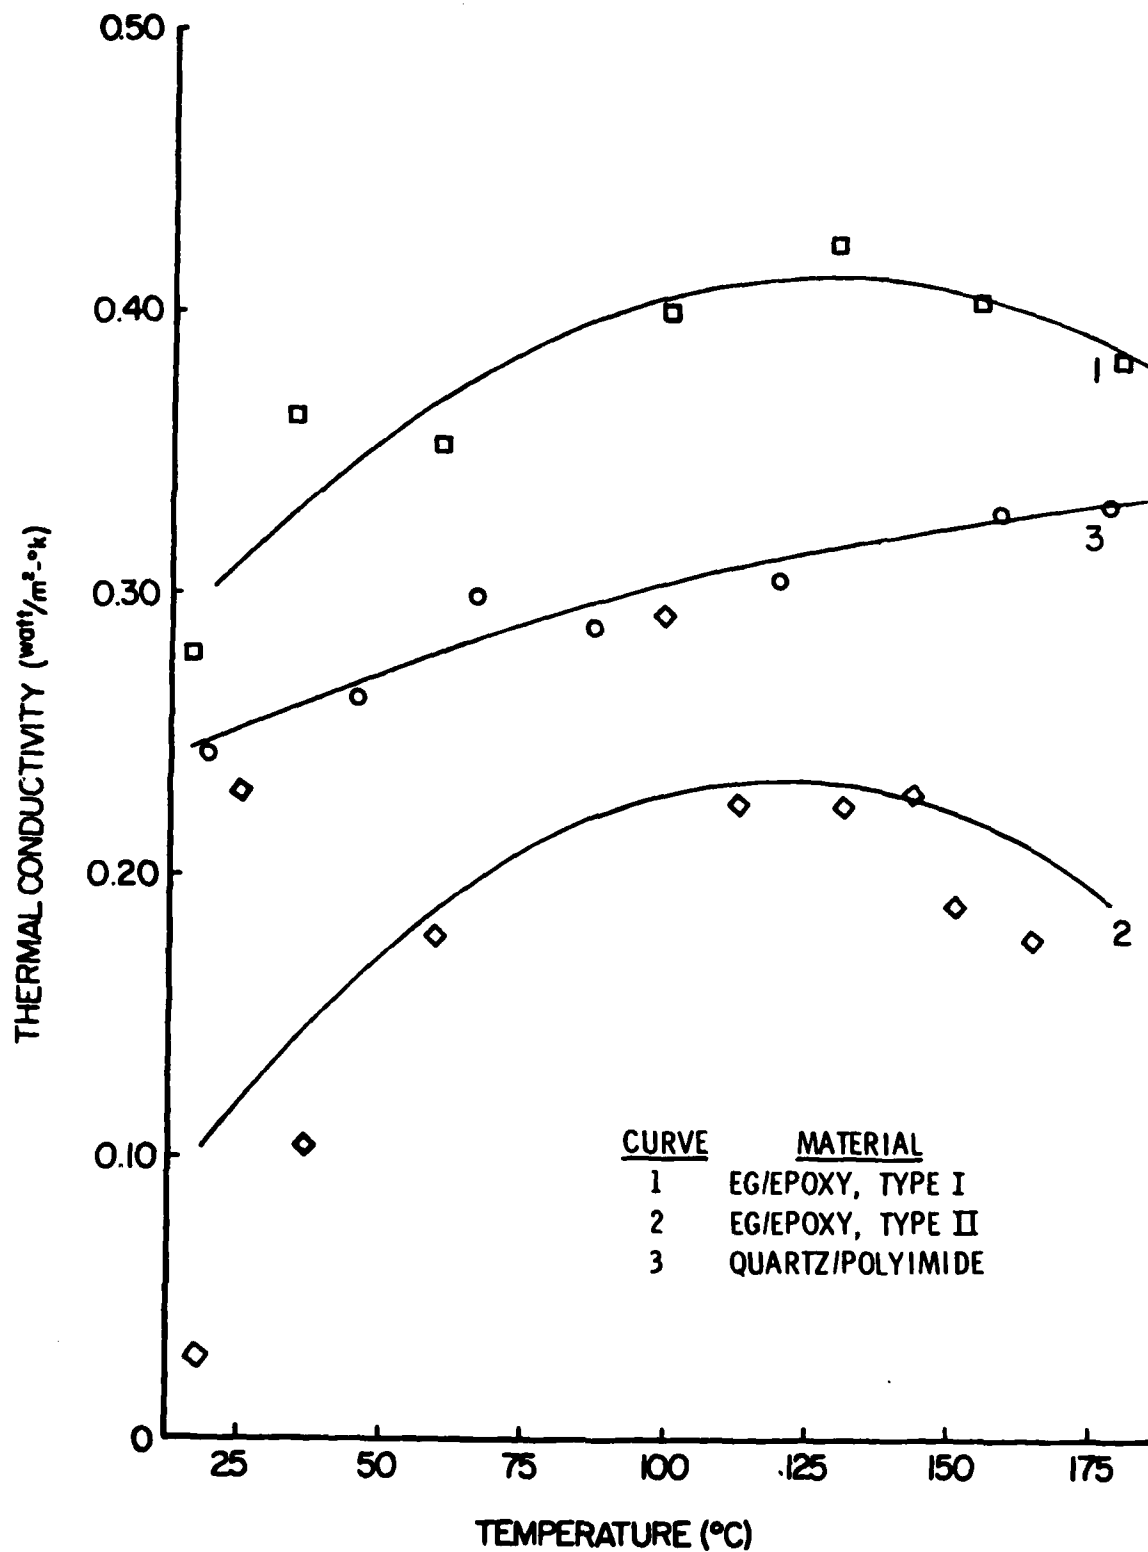
Figure 63. Thermal Conductivity Curves on EG/Epoxy Type 1 and 2 and Quartz 581/PMR-15 Laminates.

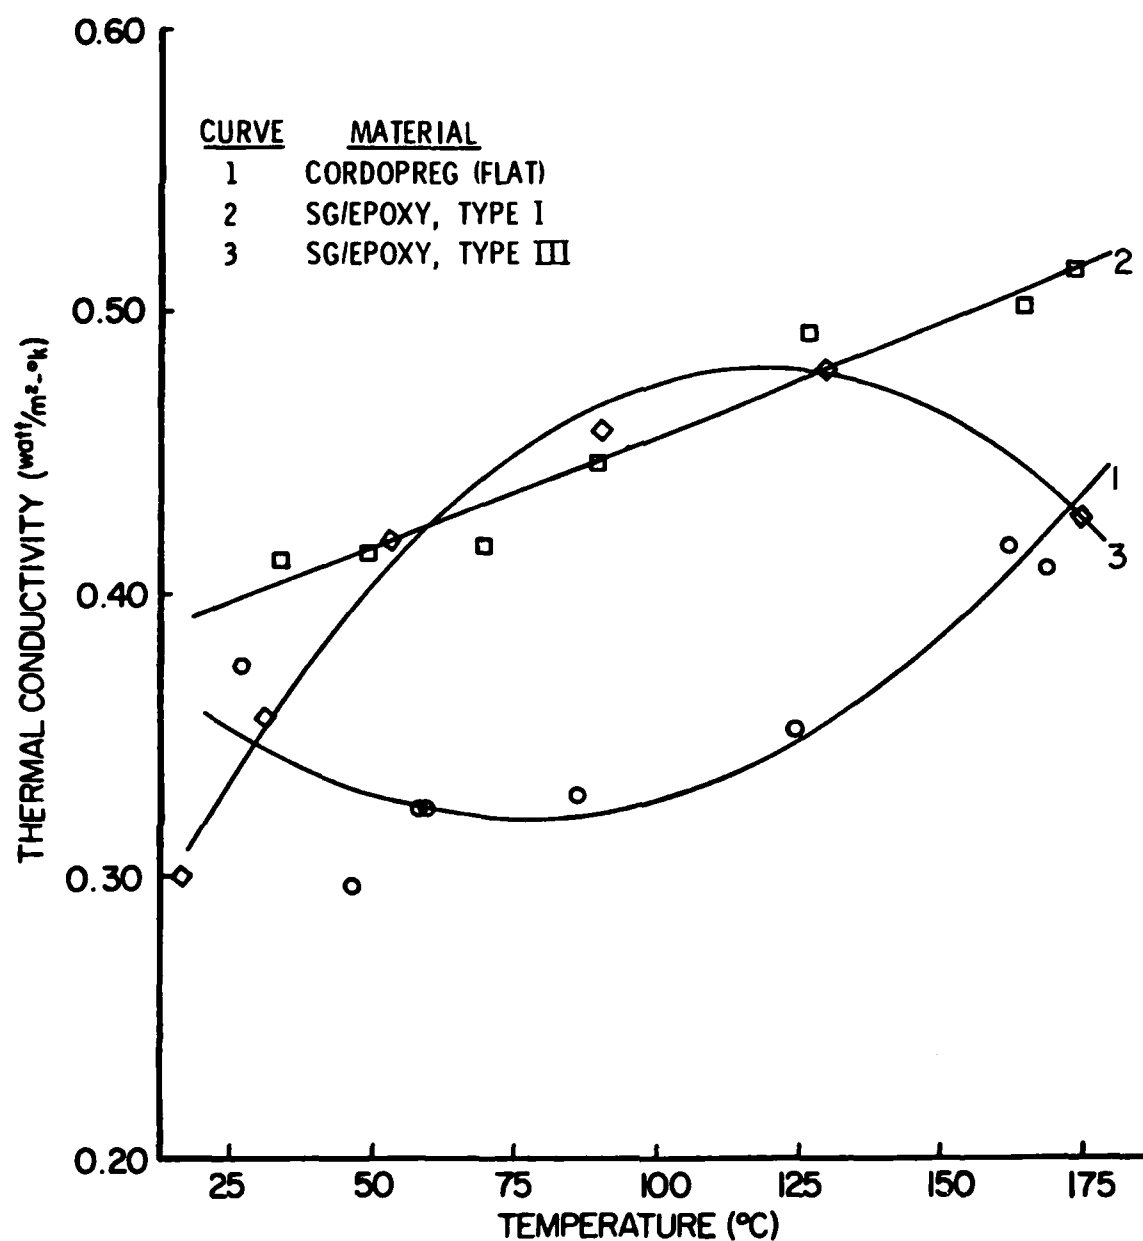
Figure 64. Thermal Conductivity Curves on SG/Epoxy Type 1 and 2 and Cordopreg Laminates.

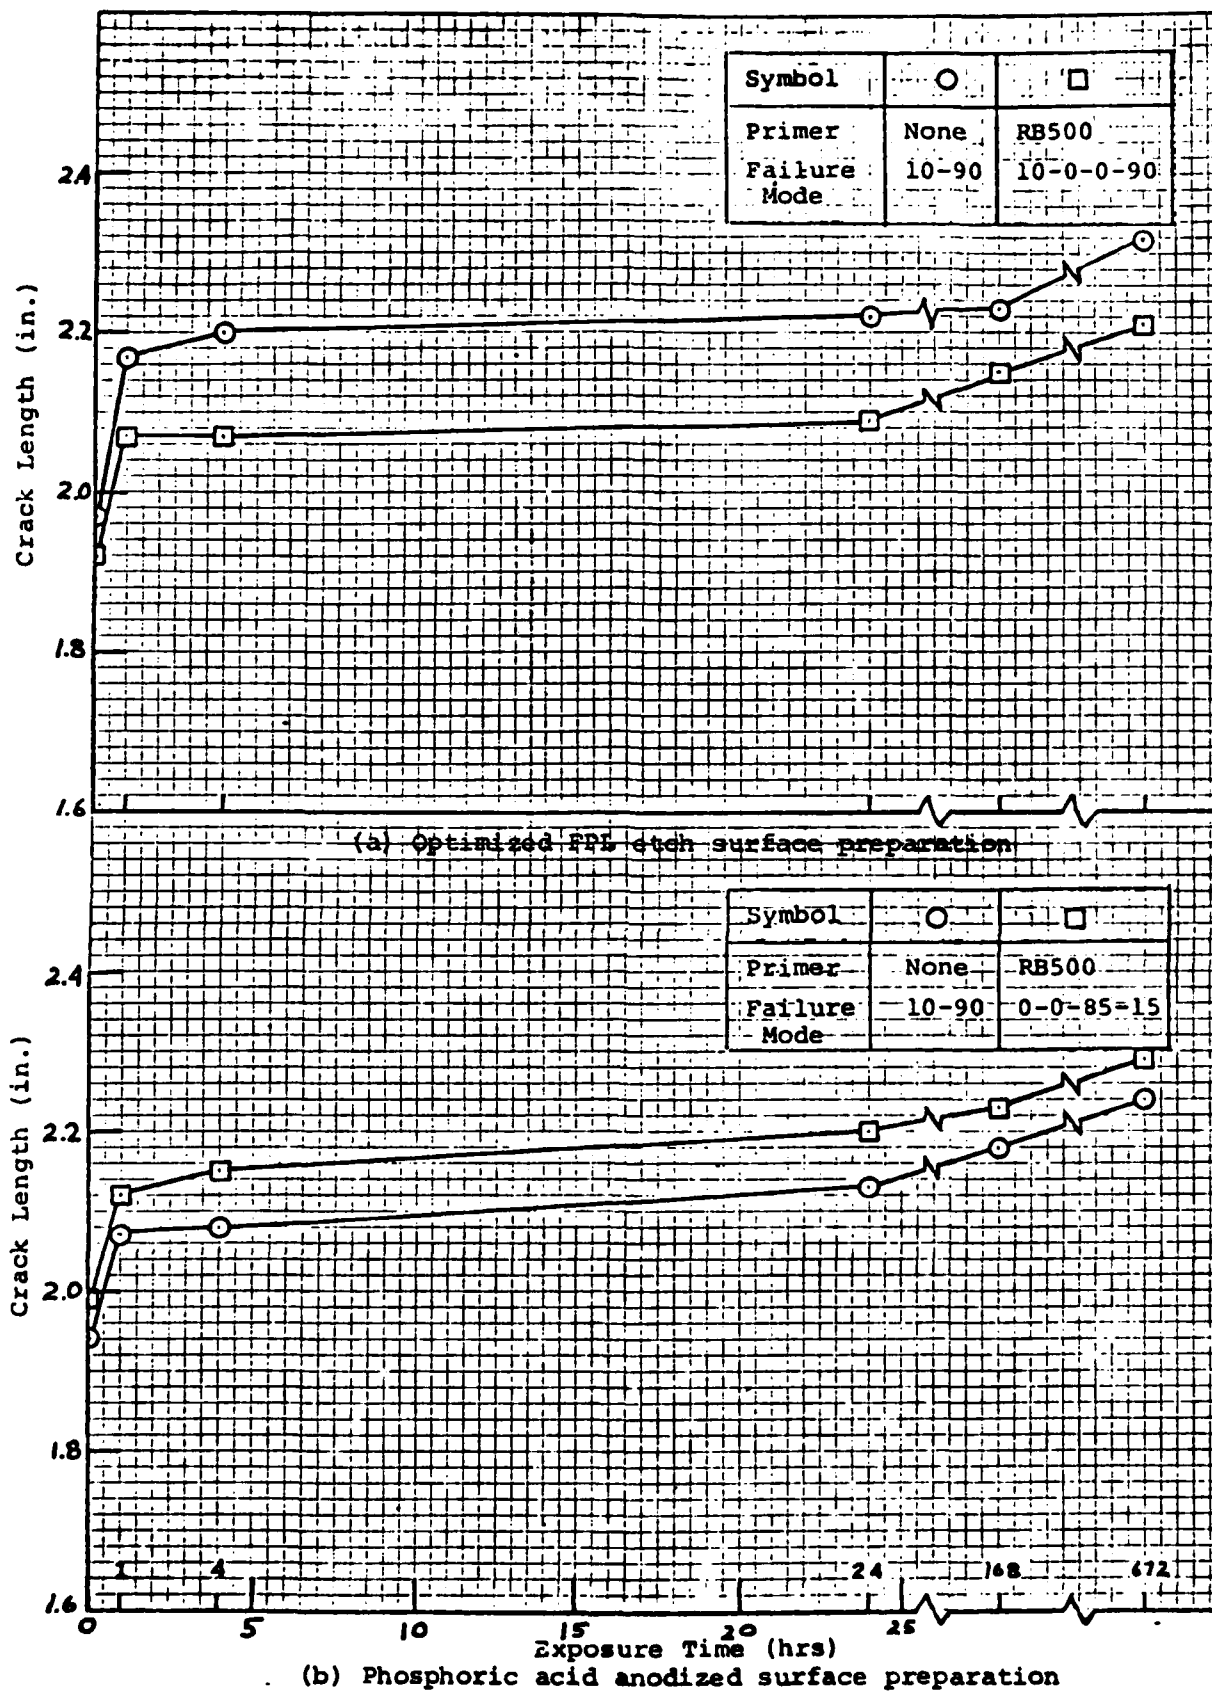
Figure 66 . Wedge Crack Propagation Results for Reliabond 398 Adhesive on 2024T81 Aluminum Adherends in Salt Fog Environment.
